**NEW HOPE**  
GROUP

## 8. Aquatic Ecology

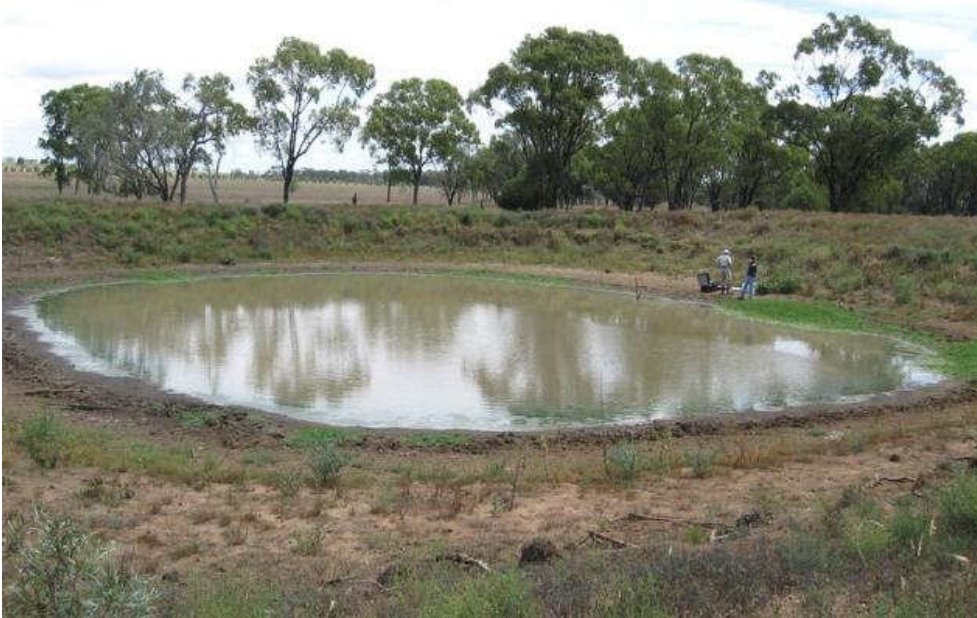
**Photograph 8-1 Site AE1 In-stream Farm Dam**

Site AE1, as shown in **Photograph 8-1**, was an in-stream farm dam located upstream of the revised Project site. This survey site was highly disturbed by modification of the stream channel and disturbance from cattle accessing the dam. The substrate was fine silt and mud. The substrate assemblage has been modified due to sedimentation of fine particles present in surface water run-off during flow events. There was evidence of bank erosion, most of which was located directly upstream of the dam. The presence of macrophytes, filamentous algae and woody debris was recorded. No

overhanging vegetation was present at the survey site. Site AE1 was assessed to be highly disturbed due to very substantial modification of the watercourse channel and cleared riparian vegetation.

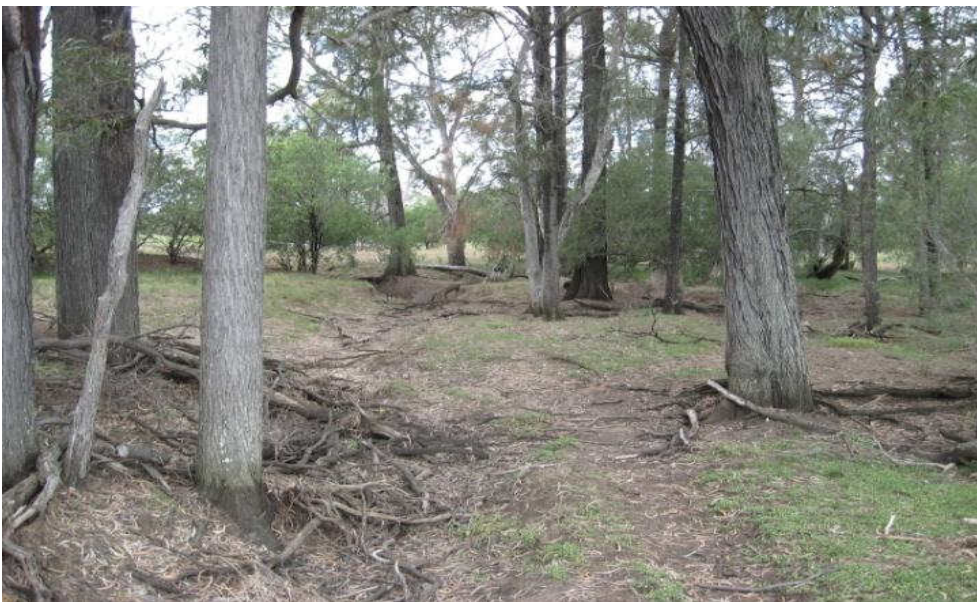
**Photograph 8-2 Views of the Channel Upstream of Site AE1**

The Lagoon Creek channel upstream of the survey site was dry as presented in **Photograph 8-1**, and consisted of narrow braided channels draining into the farm dam. These channels would flow during substantial rainfall events and would provide aquatic habitat when inundated.

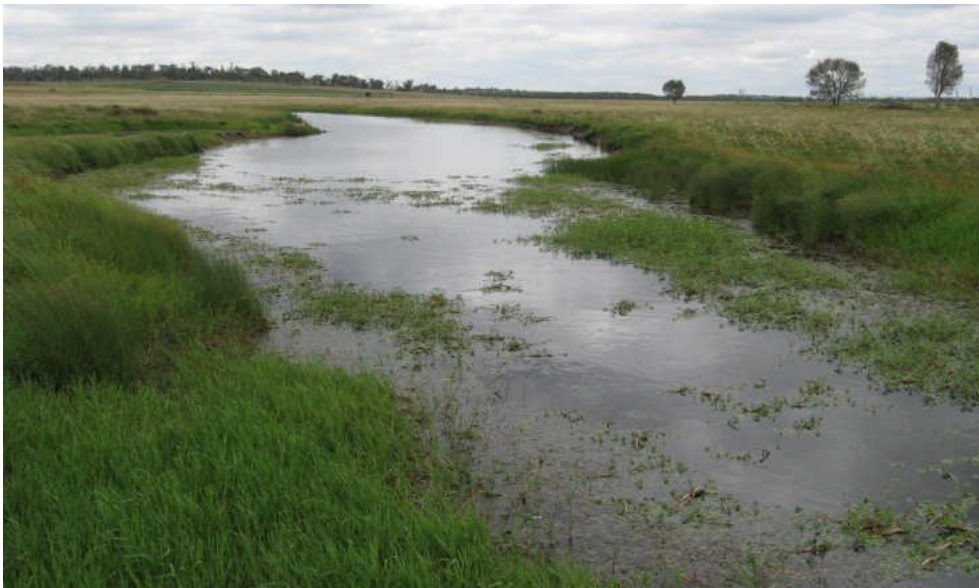
**Photograph 8-3 Site AE2 Downstream Views**

Site AE2, as shown in **Photograph 8-3**, was located downstream of the revised Project site. The waterbody at this survey site was approximately 250 m long and 8 m wide and formed by a downstream impoundment. This survey site was moderately disturbed with no riparian or overhanging vegetation present. The substrate at this survey site was compacted sand and silt with macrophytes present. Evidence of bank erosion was visible downstream, although no other waterbodies were identified. The surrounding land use is dominated by cropping (upstream) and cattle grazing (downstream). Site AE2 was assessed to be moderately disturbed due to the modification of the watercourse channel and the removal of riparian vegetation.

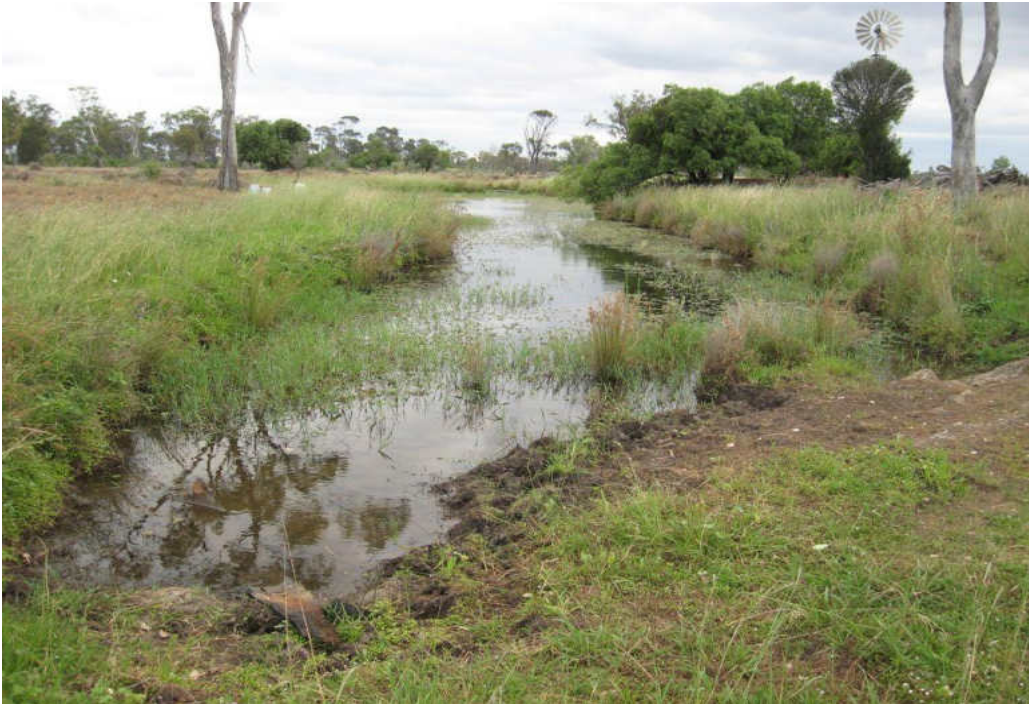
**Photograph 8-4 Site AE3 Downstream View**

Site AE3 as shown in **Photograph 8-4**, was located upstream of the revised Project site. The channel was modified due to a downstream impoundment. This survey site provided aquatic habitat with abundant macrophytes and large woody debris, and variations in depth. Overhanging vegetation was provided by trees, fringing ground cover and macrophytes. The substrate at this survey site was a combination of sand and silt. Erosion and reduced bank stability were prevalent around the edges of the waterbody due to cattle access along the riparian zone. Site AE3 was assessed to be moderately disturbed due to modification of the watercourse channel and the removal of riparian vegetation.

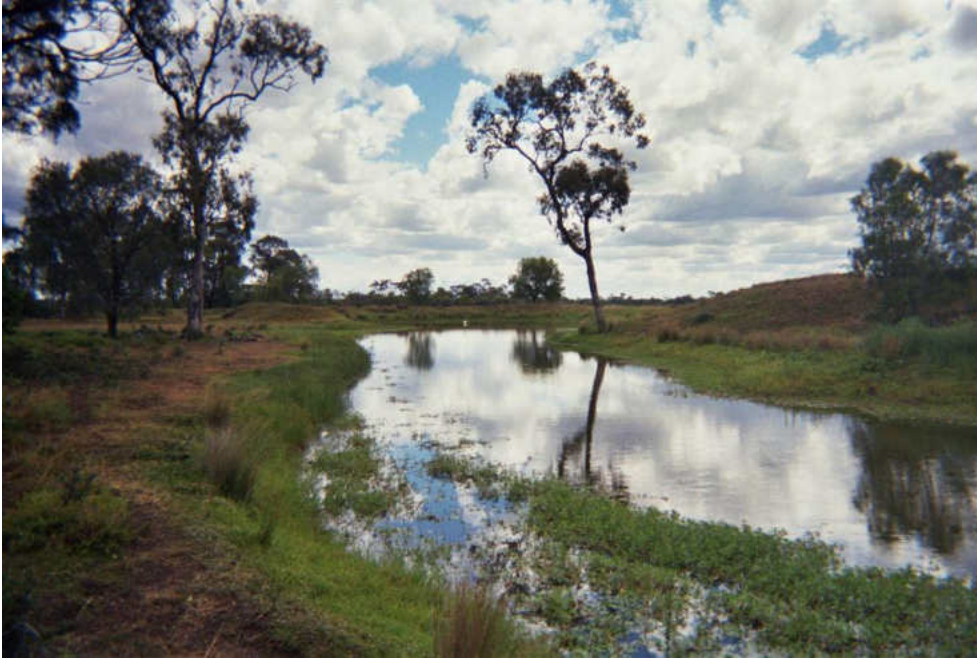
**Photograph 8-5 Site AE4 Downstream View**

Site AE4 as presented in **Photograph 8-5** was located approximately 300 m downstream of Site AE3. This waterbody was a large instream farm dam that backed up water for approximately 150 m. A small amount of overhanging vegetation was present and was represented by a large tree and macrophytes. Riparian vegetation was very limited. The substrate at this survey site was a combination of sand and silt. The only visible aquatic habitat was macrophytes that were located around the edges of the waterbody. Site AE4 was assessed to be moderately disturbed due to modification of the watercourse channel and the removal of riparian vegetation.

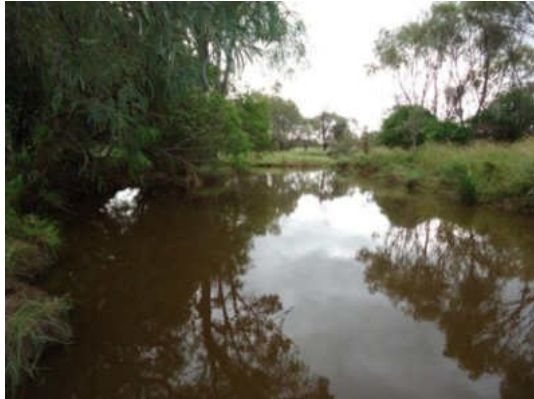
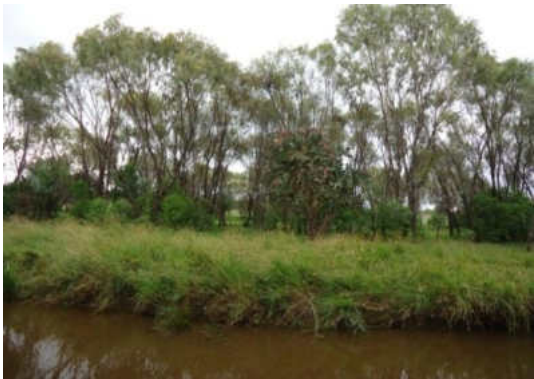
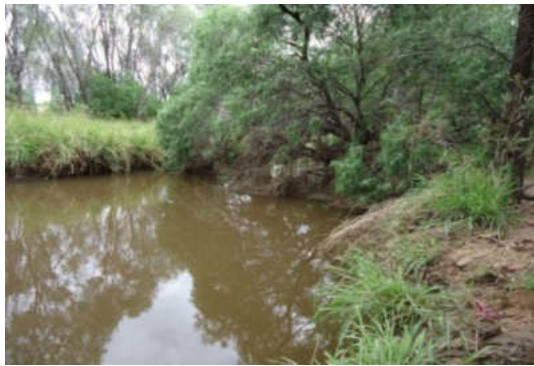
**Table 8–6 Lagoon Creek Watercourse Habitat Assessment: Survey Site AH4**

Survey Site AH4	
<b>Stream flow classification:</b>	Intermittent flow
<b>Aquatic and riparian habitat condition:</b>	Good – 54 % (Refer to site description below)
<b>Permanent surface water habitat:</b>	No
Channel characteristics	
Reach length (m)	70
Channel habitat	Run
Average wetted width (m)	5
Maximum Depth (m)	< 1
Flow	Yes
Dominant substrate in reach (%)	Silt (95)
Instream cover (%)	Large woody debris (5)
Riparian characteristics	
Canopy cover (%)	Lhb = 15 Rhb = 30
Riparian width (m)	Lhb = 15 Rhb = 10
% native/exotics trees	100/0
% native/exotics ground cover	0/100

Downstream view	
<ul style="list-style-type: none"> <li>■ Channel habitat: flowing shallow run located between upstream and downstream grassed riffles; low amount of instream cover, predominantly large woody debris.</li> <li>■ Riparian zone and banks: canopy dominated by native trees, partially intact on both banks; some bank erosion; ground cover dominated by exotic species.</li> <li>■ Watercourse impacts: barriers to fish and turtle movement from instream impoundments.</li> <li>■ Land use and impacts: agriculture including cattle grazing; cattle tracks, pugging and slumping on banks.</li> </ul>

The value and extent of aquatic habitats of the Lagoon Creek channel were assessed to improve during periods of flow, with the condition of Site AH4 rated as good and the condition of Site AH6 rated as fair during wet season field assessments. Channel habitat had some variability during periods of flow, consisting of temporary pools and riffles. The water depths recorded in pools during the survey were shallow (< 1 m), but provided connectivity between permanent surface water habitat, which allows for the movement and dispersal of aquatic flora and fauna. Instream cover within the channel was not abundant and substrate was dominated by silt. However, the presence of intact sections of riparian vegetation at sites AH4 and AH6 indicated some functionality of the system including input of woody debris, shade and the presence of edge habitat.

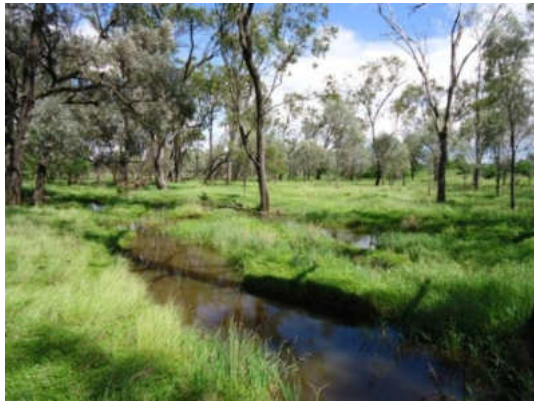
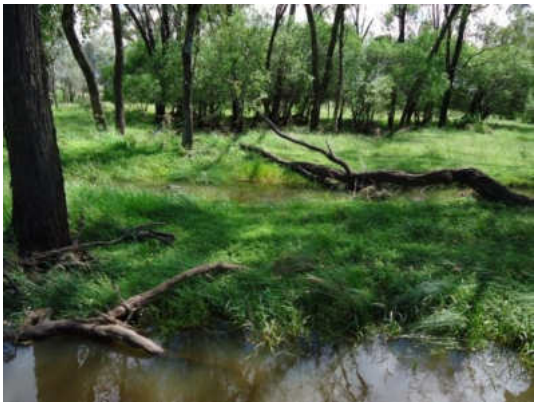
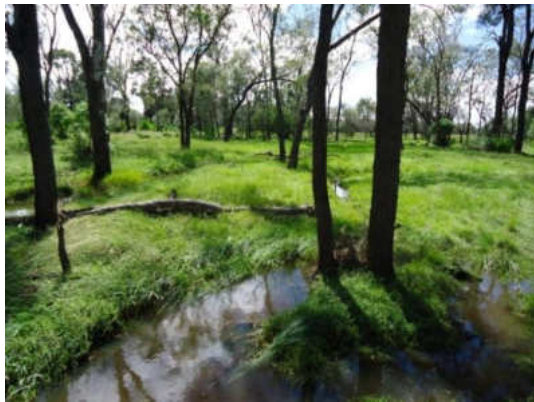
**Table 8–7 Lagoon Creek Watercourse Habitat Assessment: Survey Site AH6**

Survey Site AH6		
<b>Stream flow classification:</b>		Intermittent flow
<b>Aquatic and riparian habitat condition:</b>		Fair – 45 % (Refer to site description below)
<b>Permanent surface water habitat:</b>		No
Channel characteristics		
Reach length (m)	70

Channel habitat	Run	
Average wetted width (m)	1	
Maximum Depth (m)	< 1	
Flow	Yes	
Dominant substrate in reach (%)	Silt (95)	
Instream cover (%)	Large woody debris (10)	
Riparian characteristics		
Canopy cover (%)	Lhb = 5 Rhb = 15	Upstream view
Riparian width (m)	Lhb = 20 Rhb = 50	
% native/exotics trees	100/0	
% native/exotics ground cover	3/97

Cross section view		
<ul style="list-style-type: none"> <li>■ Channel habitat: narrow braided shallow run; low amount of instream cover, predominantly large woody debris.</li> <li>■ Riparian zone and banks: canopy dominated by native trees, partially intact on the right hand bank, substantially cleared on the left hand bank; some bank erosion; ground cover dominated by exotic species.</li> <li>■ Watercourse impacts: barriers to fish and turtle movement from instream impoundments.</li> <li>■ Land use and impacts: agriculture including cattle grazing; cattle tracks, pugging and slumping on banks.</li> </ul>

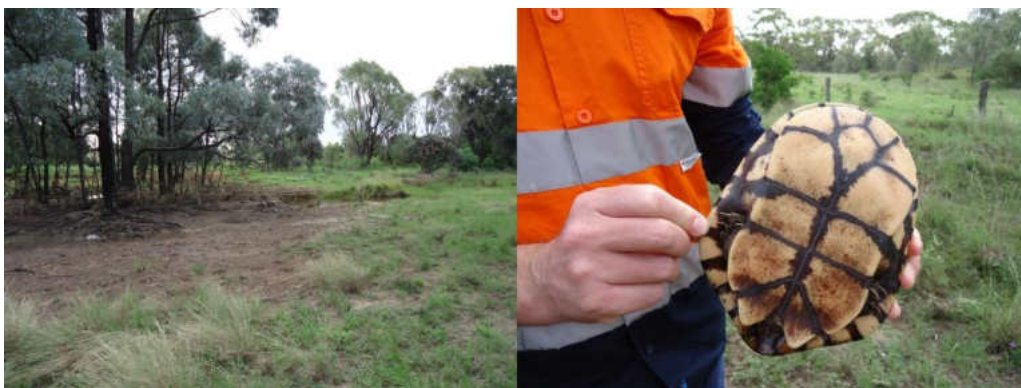
**Photograph 8-6 Lagoon Creek Channel and Eastern Snake-Necked Turtle Upstream of AH4**

The single turtle species observed along the Lagoon Creek Channel, inhabits slow moving water bodies from farm dams to major rivers and lakes. Due to their ability to move over land to find water, they are able to inhabit shallow lakes and ephemeral waterbodies (Chessman 1988). The broad-shelled river turtle has a preference for aquatic habitat with structured vegetation including emergent and submerged macrophytes, submerged logs, dead trees and root system (Ercolano 2008). The low availability of structural habitat and cleared riparian vegetation and absence of submerged macrophytes suggests Lagoon Creek is unlikely to support populations of the broad-shelled turtle. The Murray turtle is highly unlikely to be found in the aquatic ecology study area due to its habitat preference for large river and permanent lakes (Chessman 1988) both of which are not present in the Study area. Turtle species were not reported in the surveys of Charleys Creek (Hydrobiology 2010), Gowrie Creek (Aquateco 2011) and Wilkie Creek (SKM 2012) although these larger water courses are likely to have potential habitat for all three species.
